# AUDIT REPORT

DOE-OIG-20-37

**THE DEPARTMENT OF ENERGY'S  
WILDLAND FIRE PREVENTION  
EFFORTS AT THE NEVADA NATIONAL  
SECURITY SITE**

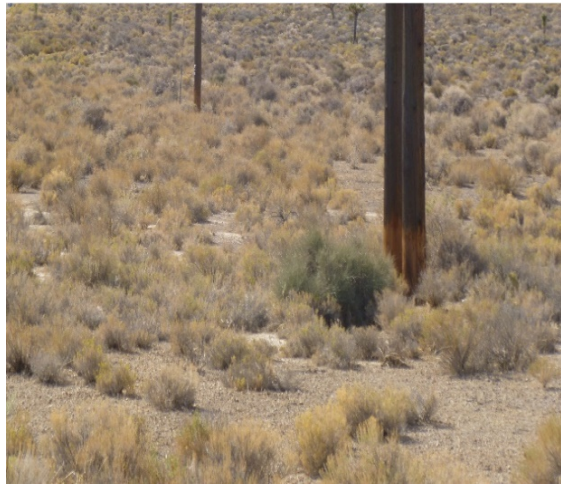
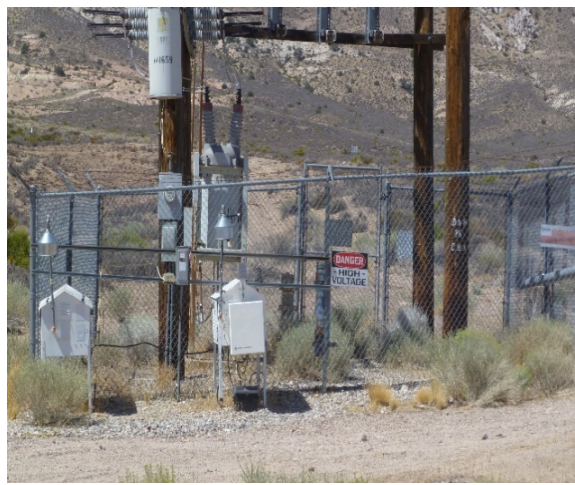
We found that mitigation activities such as treating or removing excess vegetation needed to ensure defensible space and firebreaks around facilities, combustible utility poles, and along roadways were not being completed as required by NFPA standards and IWUIC. Defensible space and firebreaks are necessary for suppression efforts to reduce the size of wildland fires, protect NNSS property from wildland fire exposure, and minimize the potential of structure- or roadway-related combustible sources igniting wildland fires. Under NFPA 1141, NFPA 1144, and IWUIC, the contractor is required to modify or remove wildland fire fuels around structures and along roadways to reduce ignition sources. However, during our fieldwork, we observed several areas where excess vegetation had not been treated or removed as required. For example, we noted brush around the base of combustible utility poles, vegetation within the fence line of an electrical substation, and overgrown brush along roadways leading to facilities and communication sites. In addition, a road assessment conducted by the contractor in 2017 also identified issues related to excess vegetation along roadways. Specifically, the assessment indicated that roads previously used as firebreaks could no longer be utilized as such due to a lack of vegetation abatement.

The following pictures illustrate the conditions we observed:

Examples of vegetation around utility poles (left) and within the fence line of an electrical substation (right)  
(Pictures taken and provided by NNSS officials)

In addition, consistent with our observations above, annual wildland fire vegetation assessment reports prepared by the contractor for calendar years (CYs) 2014 through 2018 repeatedly identified areas that did not meet defensible space requirements in accordance with NFPA 1141, NFPA 1144, and IWUIC. For example, communication sites that support critical equipment such as fire watch cameras, air to ground radios, and handheld radios used by emergency responders were repeatedly identified as not meeting vegetation clearance requirements, making the sites vulnerable to damage if a wildland fire were to occur. Additionally, radiologically contaminated areas, which remain at NNSS as a result of past nuclear testing, were consistently identified as not meeting requirements for vegetation clearance along roadways. This was concerning because, according to the Plan, vegetation that is radiologically or chemically contaminated could result in airborne contamination if ignited, which could impact emergency responders. Further, the 2018 vegetation assessment report noted that utility poles on the western side of NNSS's power distribution system, which services all facilities and other structures, had not been cleared of vegetation as required. If a wildland fire were to burn utility poles in this area, the potential exists for the power supply to facilities to be disrupted, which could impact mission critical work as demonstrated during a 2018 wildland fire at NNSS. According to the contractor's Fire Marshal, vegetation accumulating at the base of combustible utility power poles has resulted in numerous high-dollar loss fires at NNSS. By not performing mitigation activities, NNSS facilities and other structures are at an increased risk of being impacted by a wildland fire.

1. Conduct a complex-wide wildland fire risk assessment to ensure that risks are fully understood and analyzed;
2. Based on the risk assessment results, develop a mitigation plan in accordance with NFPA requirements;
3. Reevaluate the proposed reduction in the number of miles of roads to be maintained to ensure that emergency response implications are fully considered; and
4. Develop a formal tracking mechanism to ensure that preparedness activities, including logistics, are completed prior to the start of a wildland fire season.

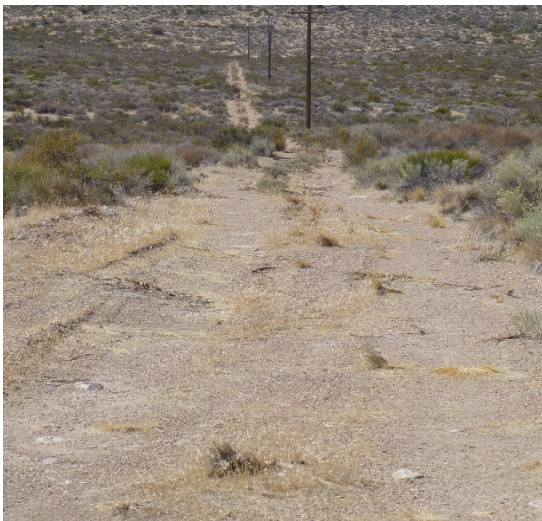
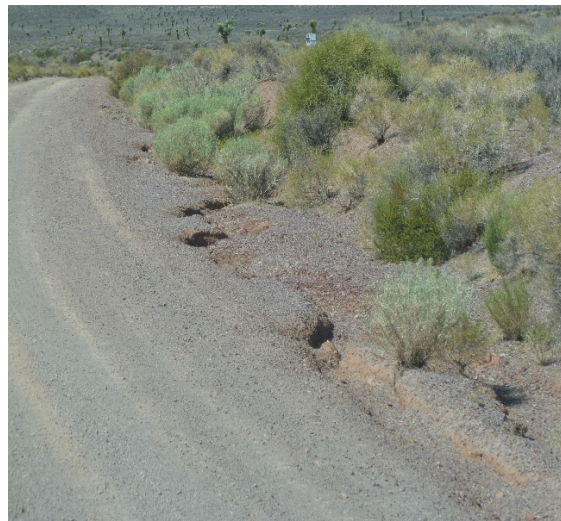
We found that roads necessary for protecting utilities and providing access for firefighters and equipment had not been maintained as required. Under NFPA 1141 and IWUIC, roads are required to provide a minimum road width and vertical clearances to allow two vehicles to pass and accommodate the loads and turning radii for fire apparatus. However, during our fieldwork, we observed roads that did not meet these requirements. For example, we noted roads with deteriorated conditions, including washouts, which limited the ability for vehicles to pass or turn around and restricted the types of vehicles that could respond. These roads provide access to communication sites located in remote areas where wildland fires have occurred at NNSS. Additionally, the lack of turn around areas may cause a bottleneck of responding vehicles and personnel, creating entrapment and hindering response times. Similar conditions were also noted in a 2017 road assessment conducted by the contractor, which stated that roads used to access communication sites were not wide enough for emergency vehicles to pass or turn around when responding to fires. The following images illustrate the conditions described above:

Examples of roads with deteriorated conditions  
(Pictures taken and provided by NNSS officials)

The contractor's road assessment also highlighted deteriorated road conditions across NNSS. In particular, the assessment, the purpose of which was to evaluate the overall condition of NNSS's road network and identify improvement projects, found that the majority of roads had surpassed their design life and continued to deteriorate due to inadequate maintenance funding. Additionally, the assessment noted that the deteriorated road conditions have seriously impaired

the ability to safely support current personnel and operations, which could impact future mission expansion. The road assessment proposed, and the contractor began implementing, a significant reduction in the number of road network miles that would be maintained across NNSS – from 1,401 miles of maintained roads to 352 miles of maintained roads, a reduction of almost 75 percent. When we questioned contractor officials about the reduction, they indicated that emergency response needs were not considered when the proposal was developed. In addition, the proposed reduction was not coordinated with the Nevada Field Office or across all contractor organizations, including its emergency operations and fire department, to evaluate the impact on their operations. The reduction in miles maintained is concerning because it impacts emergency response times, limits access to remote areas, and may hinder evacuation efforts in the event of a wildland fire.

*Management Response:* Concur. NNS Fire and Rescue will review the 2017 road assessment to validate that emergency response operations will not be impacted by the reduction. The NNS Wildland Fire Management Plan will also be updated to require NNS Fire and Rescue be involved in future road maintenance decisions.
