OIG Deployment Activities at FEMA's Joint Field Office in Charleston, West Virginia - Yeager Airport

OIG Deployment Activities at FEMA's Joint Field Office in Charleston, West Virginia – Yeager Airport

September 15, 2015

www.oig.dhs.gov OIG 15-145-D

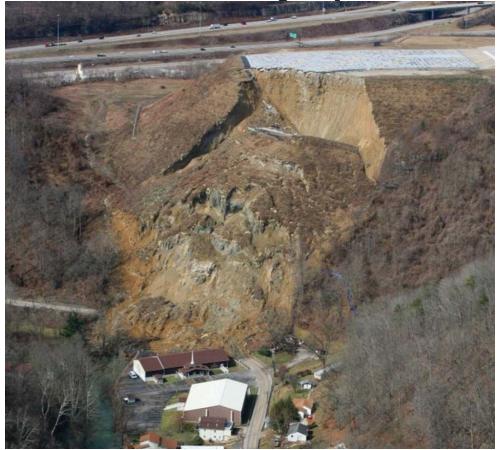
On March 12, 2015, a massive landslide below Yeager Airport in Charleston, West Virginia, impacted the runway safety area, technically known as the Engineered Materials Arresting System-Mechanically Stabilized Earth (Engineered Arresting) structure.

the Federal Aviation Administration (FAA) required, extends the runway as an emergency airplane takeoff/landing arresting measure and consists of the runway safety area and a manmade slope. The manmade slope extended the length of the mountain upon which the Airport Authority built the original runway to enable construction of the emergency arresting system. The Airport Authority contracted to build the structure at a cost of approximately \$20 million using mechanically stabilized earth, traditional fill, and geogrids. FAA funded its construction through a grant to the Airport Authority, the owner and operator of Yeager Airport. As of the time of our deployment, the runway remained safe for landing and takeoff because the safety area of the structure was still stable and long enough to operate according to its intended function and current FAA requirements. Figure 1 shows the damage to the structure.

Figure 1: Damage to the Engineered Arresting Structure at Yeager Airport

FEMA should take reasonable steps to determine whether the damage to the runway safety area (i.e., the Engineered Arresting structure) at Yeager Airport is the direct result of the disaster, and, if so, that a duplication of benefits does not occur. Further, FEMA should fully document such determinations in the agency's official disaster records.

In our review of documents related to the structure's damages (compiled and provided by FEMA External Affairs personnel) and in discussions with Joint Field Office and United States Army Corps of Engineers (USACE) officials, we noted that media reports as early as 2011 indicated the presence of gaps in the structure. Furthermore, in July 2013, airport workers reported slope movement during their annual maintenance work on the structure's tiles. At that time, the engineering firm that designed the structure told the Airport Authority that the slope movement was normal settlement of the two different fills (traditional and mechanically stabilized earth) used in construction of the structure. However, in late February/early March 2015, an airport inspection revealed significant movement and cracks in the structure. On March 12, 2015, the landslide occurred, damaging the structure.
